**The Grand Department Store**  
HISTORIC PRESERVATION CERTIFICATION APPLICATION  
PART 1 - EVALUATION OF SIGNIFICANCE & PART 2 - DESCRIPTION OF REHABILITATION

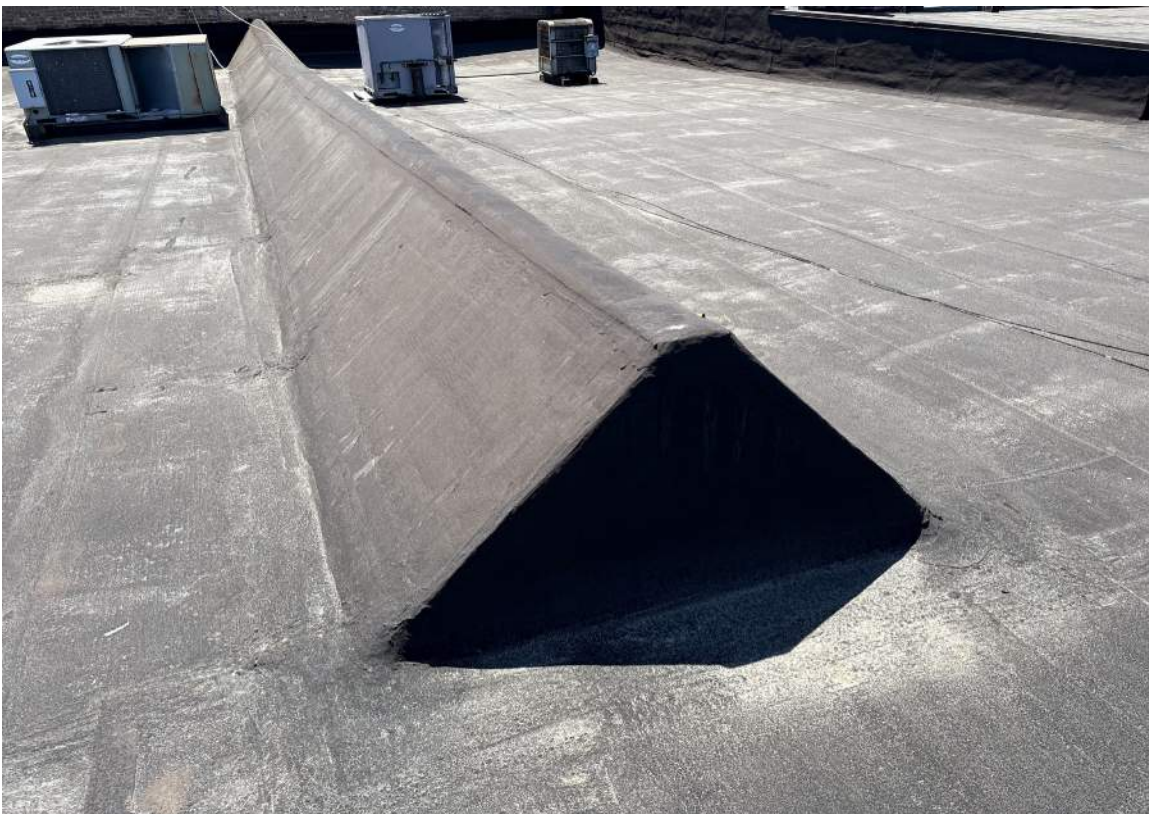
IMAGE 171: Rooftop - 1911 Structure - looking south at existing roof ridge

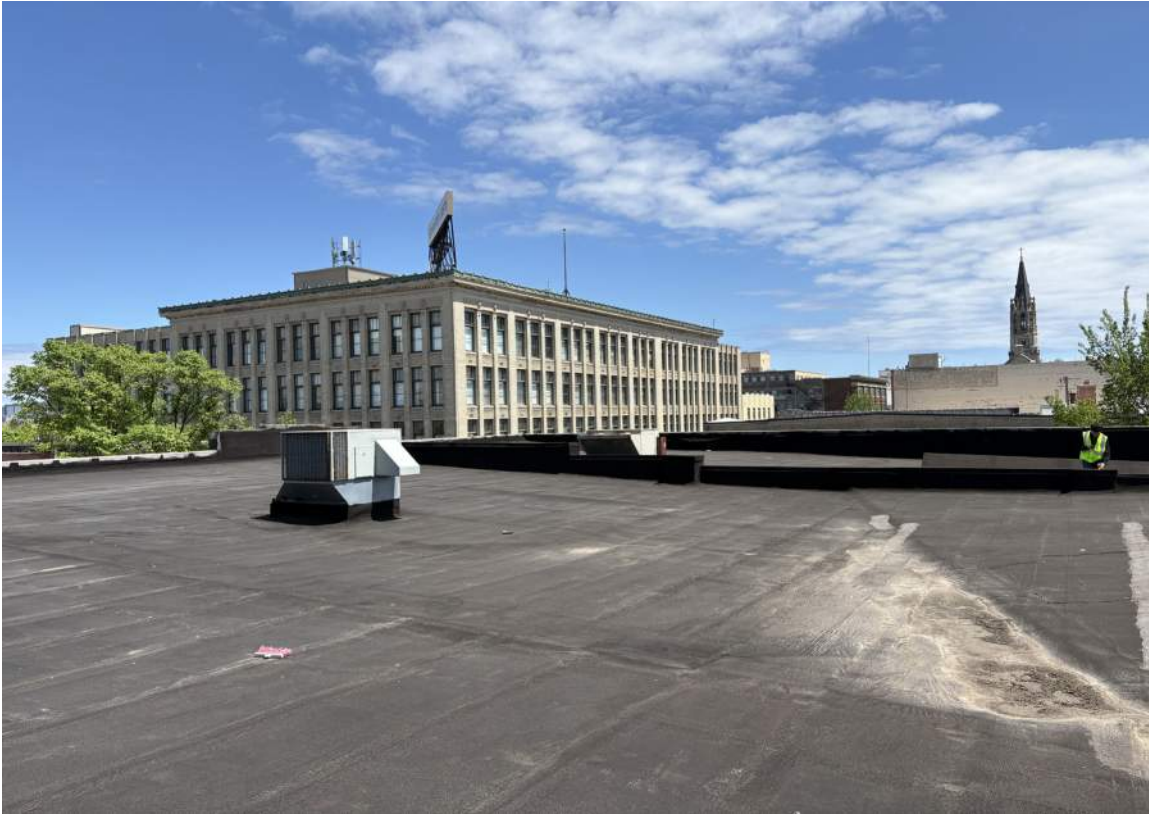
IMAGE 172: Rooftop - pre-1888 Structure - looking northeast

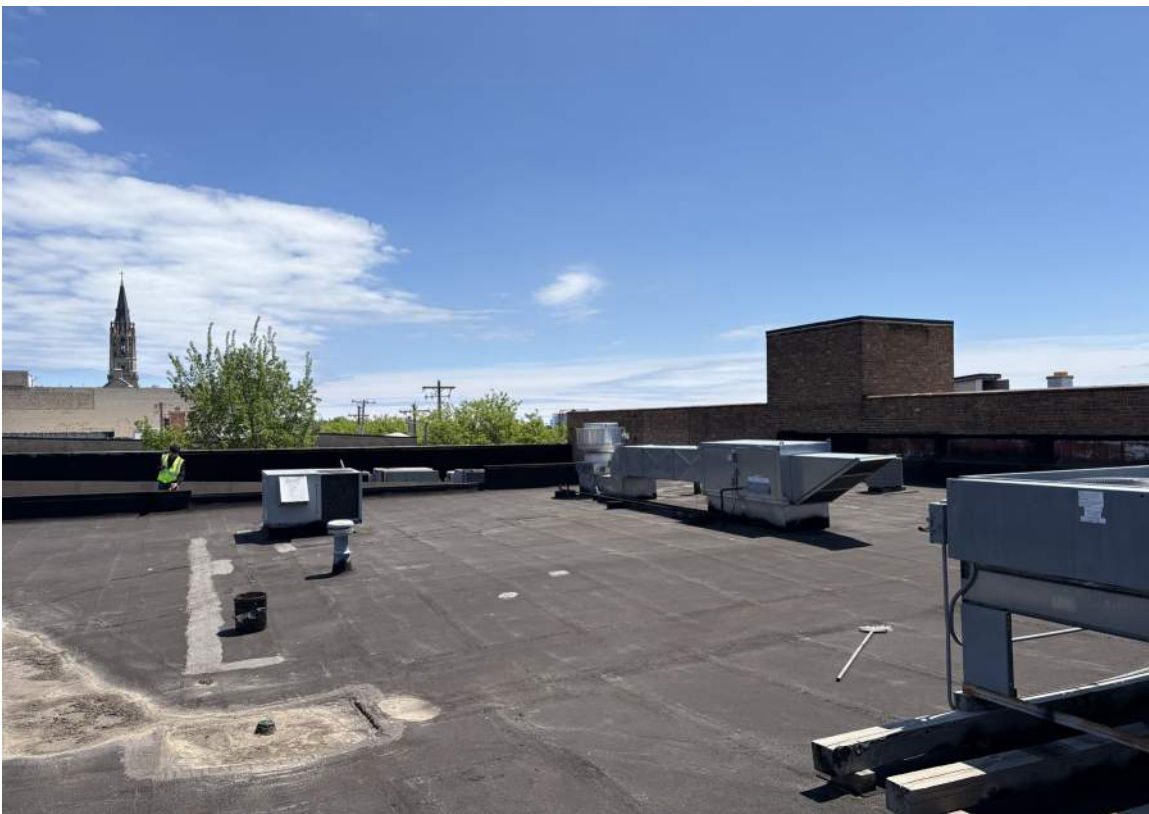
IMAGE 173: Rooftop - pre-1888 Structure - looking southeast

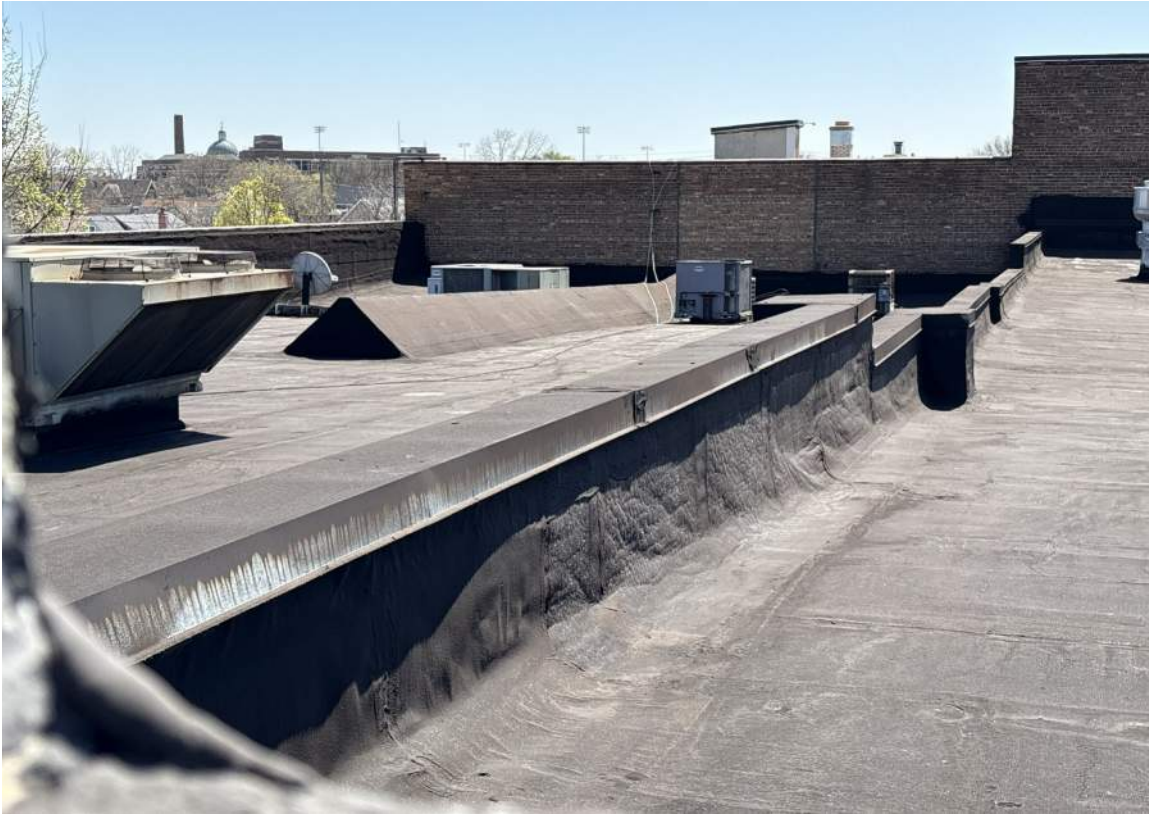
IMAGE 174: Rooftop - pre-1888 Structure - looking southeast

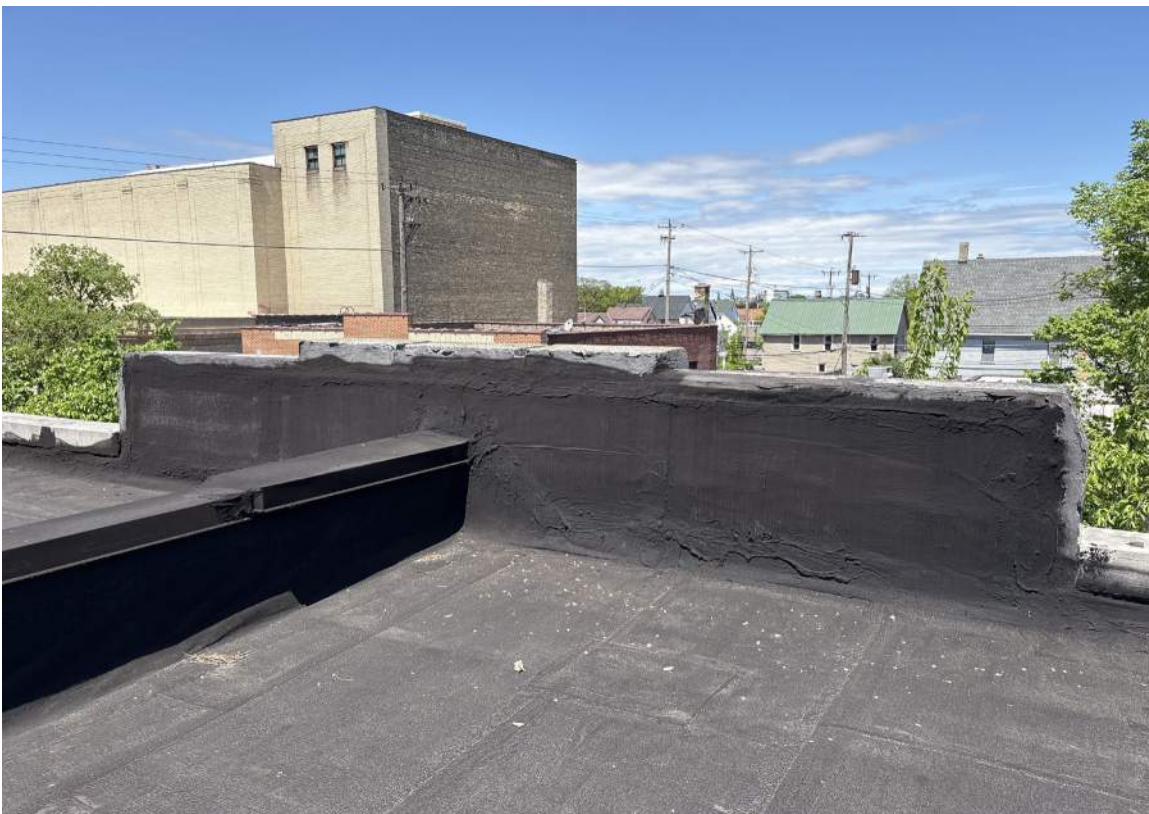
IMAGE 175: Rooftop - 1891 Structure - looking northwest at stepped parapet (backside of Art Deco ornamentation on north elevation)
