Façade Critical Examination Ordinance Report

2015 Follow-up

City of Milwaukee
North Point Water Tower

August 5, 2015

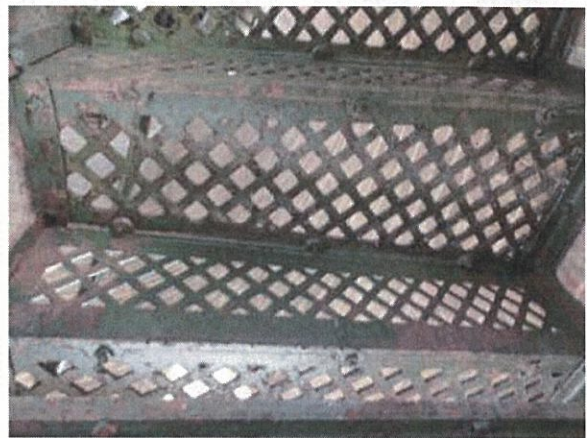
S19

The 'L' shaped 1¼"x1¼" angles are riveted to the 3/8"x 2 ½" plate stringers. The inside plate stringer is supported by a bracket that extends from the masonry brick wall typically every 11 to 12 steps (Photo S22).

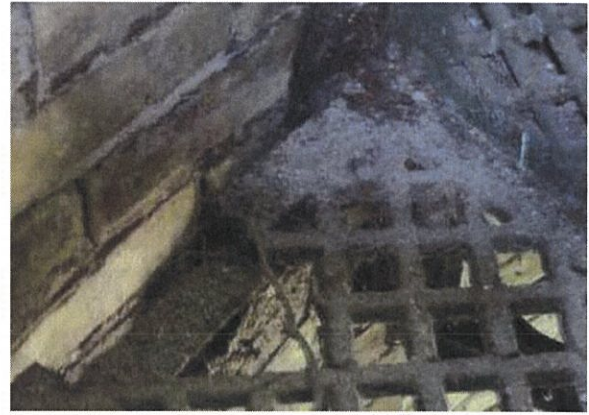
S02

The stair components (treads, risers, support angles as well as stringers) adjacent to an existing window above step #110 had some degree of corrosive damage that varied from minor (a buckled tread or flaky riser with support angles and stringers showing minimal damage) to severe (tread/riser falling apart and/or plate stringer nonexistent owing to corrosion). This damage was due to moisture infiltration from the exterior masonry brick wall adjacent to the window sill or header.

Please refer to photographs – S02, S05, S06 through S09, and S13 through S15 for the observed condition.

- Install 1/8" galvanized steel plate on top of existing treads and bolted/screwed to the existing tread that are in turn supported off of angle brackets. Verify the related support brackets are in fair condition. If not, the angle brackets must be replaced in kind first prior to putting the plate on the treads.
- Install the 3/8" plate over the corroded stringer sections. The new stringer repair plate must overlap with sound stringer plate at least 12 inches and must have two 5/8" diameter post-installed mechanical anchors (compatible to be installed in solid masonry) spaced at 8" O.C.

- the corroded stair stringers/treads/risers and associated hardware is removed and replaced in kind.
- it is not open to public and used only for the periodic maintenance (with the live loads being less than the 15 psf and 200 lb uniform and concentrated load respectively) of the tower interior.

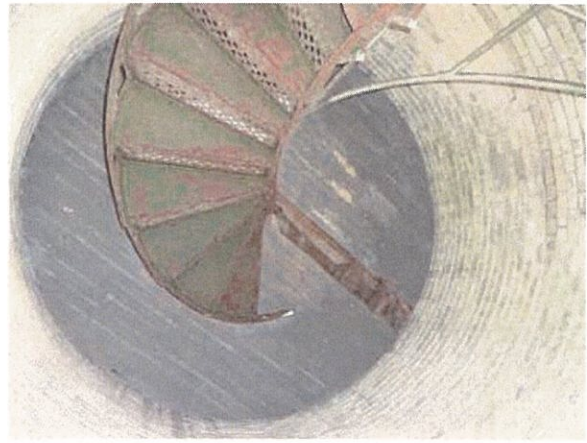
S25

'Observation Deck' platform at an approx. elevation of 135 feet: The top as well as the underside of this deck was covered with wood decking and ceiling (Photo S25). The deck structure appeared to be made up of wood / timber framing.

- Observation Deck' platform at an approx. elevation of 135 feet: A condition assessment of this platform was not possible at this time as the structure was not exposed to view.

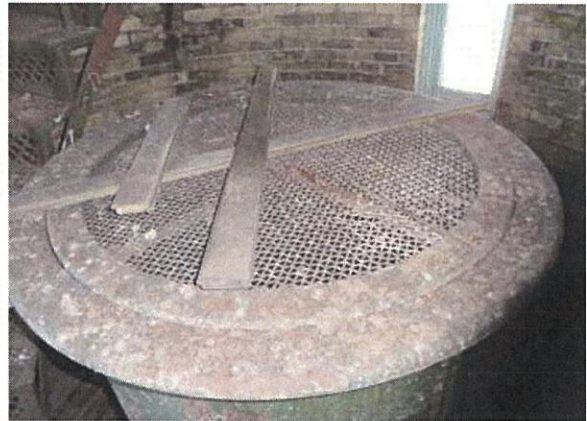
S27

Platform at an approx. elevation of 117 feet: This platform is couple of feet below the top of the standpipe (Photo S27) and is framed with steel beams that are arranged in a radial pattern around the standpipe (Photo S28).

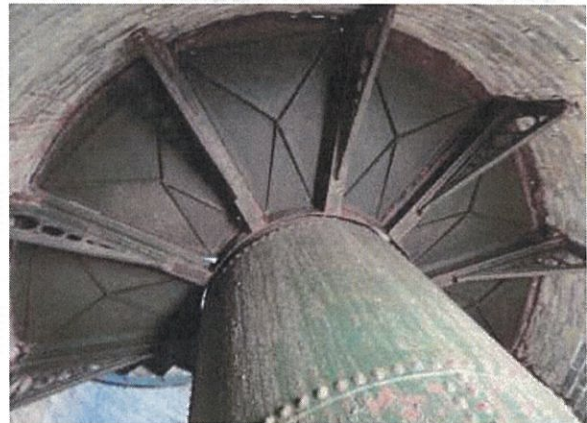
S28

- Platform at an approx. elevation of 117 feet: Apart from the checkered plate corrosion observed along the circumference of this platform, the platform framing appeared to be in good condition. We recommend replacing the checkered plate with a galvanized steel checkered plate. The existing structural steel framing should be cleaned and painted per the repair procedure described below.

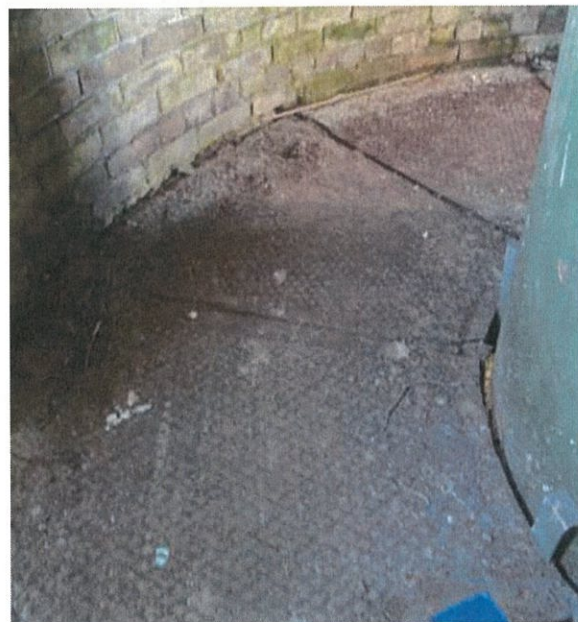
S31

A stiffened checkered plate acts as the deck over the radial beams (Photo S31).

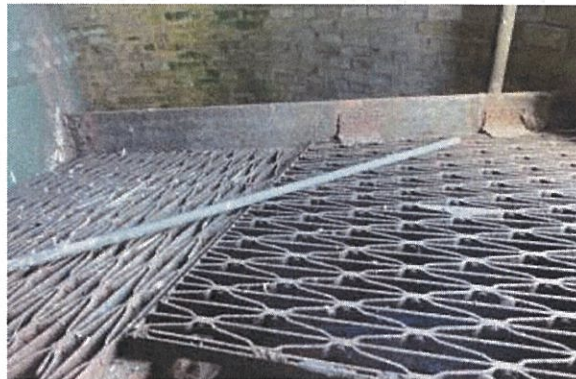
Platform at an approx. elevation of 64 feet: A metal grating supported on eight steel angles constitute the framing for this platform (Photo S33 and S34).

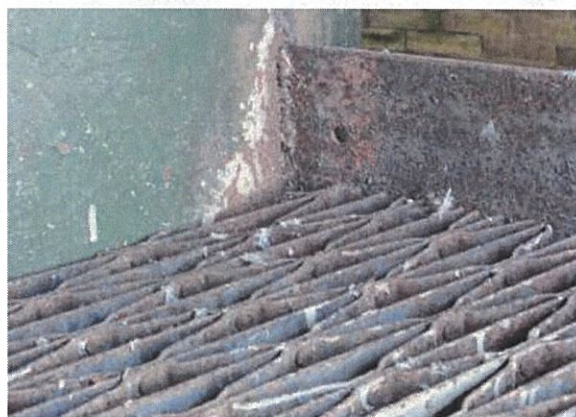
S35

All eight angles were observed to be welded to the standpipe on the inside end (Photo S35).

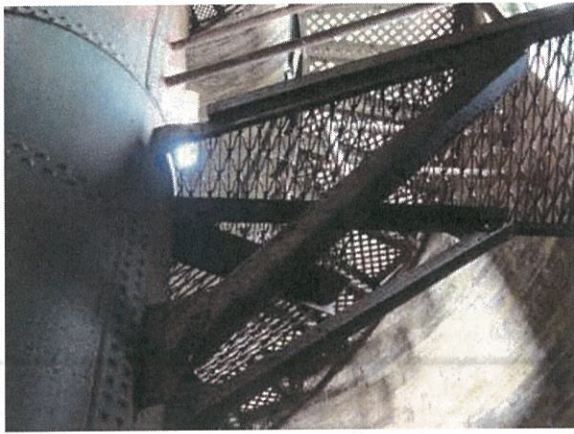
S38

To support this platform, the other two remaining angles are supported by kickers off of the standpipe (Photo S38).

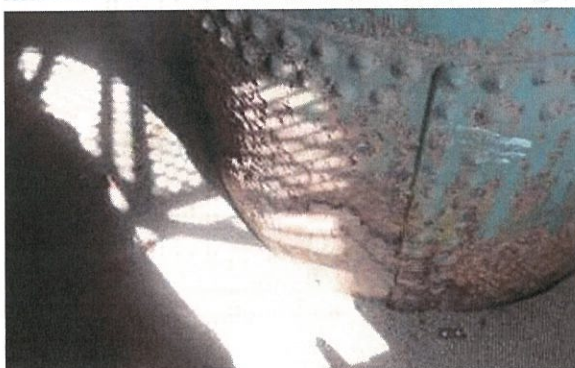
S41

A stiffened checkered plate formed the deck over the radial beams. The checkered plate along with the steel framing was observed to be corroded (Photos S40 and S41).

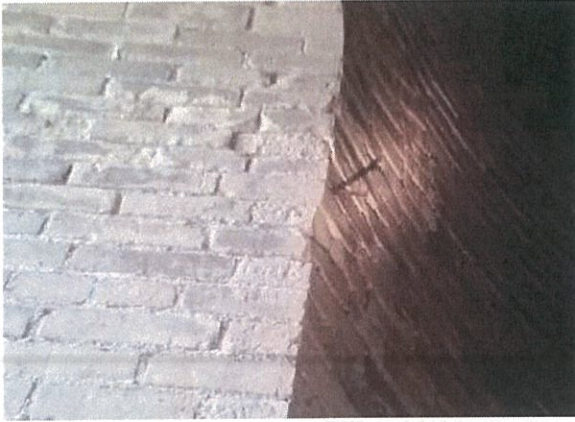
T45

Orphaned metal pin in masonry

Grade: Minor

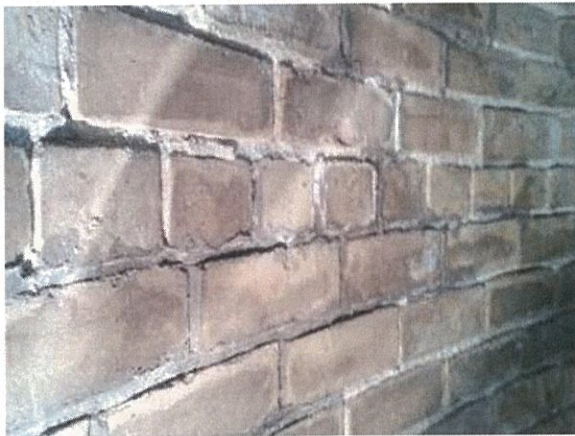
T70

Supplementary mortar added over possibly compromised mortar beds

Grade: Minor

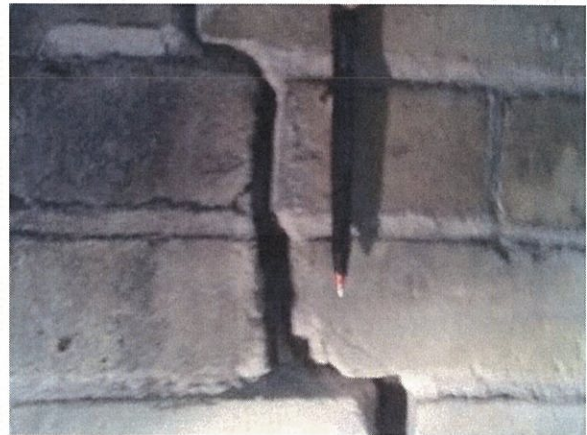
**T95**

Crack in common brick, through mortar joints and brick. Crack is above South window, movement appears to be horizontal (minimal movement)

Replace fractured bricks, repoint mortar joints

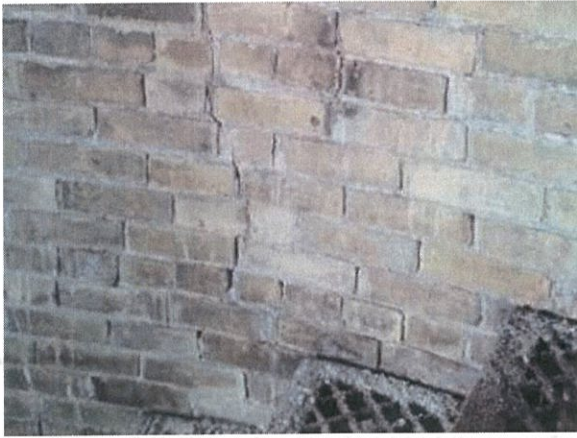
T105

Crack occurs below West window 66' A.G.P. up to 89' A.G.P., movement appears to be horizontal (1/8") but not vertical

Replace fractured bricks, repoint mortar joints

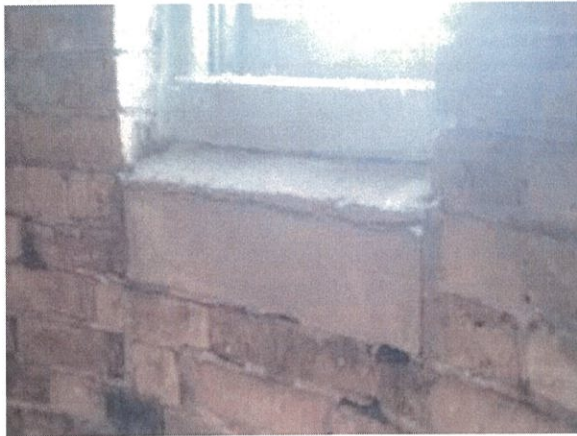
**T135
A**

Face of sill cracked from past water infiltration
Crack in brick occurs below South window extends from 92' A.G.P. down to 71' A.G.P. (Comment T95)

Remedy moisture infiltration from window, repoint mortar joints

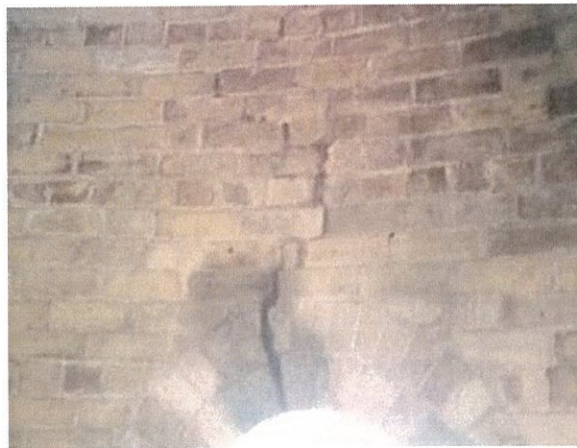
T153

Crack occurs below North window at 89' A.G.P. to 119' A.G.P.

Replace fractured bricks, repoint mortar joints

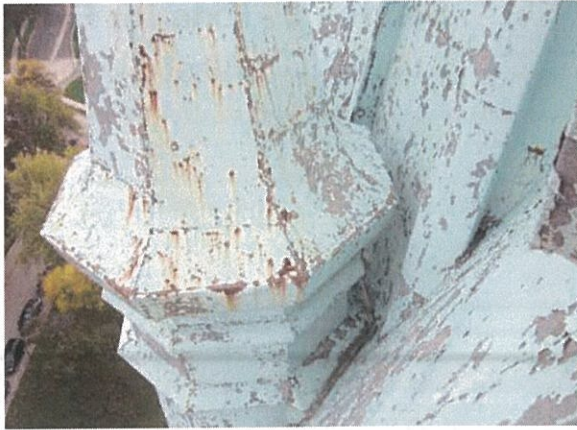
W1

Metal roof / finials: Exterior metal sheeting is intact. Peeling paint and spotting rust across entire surface

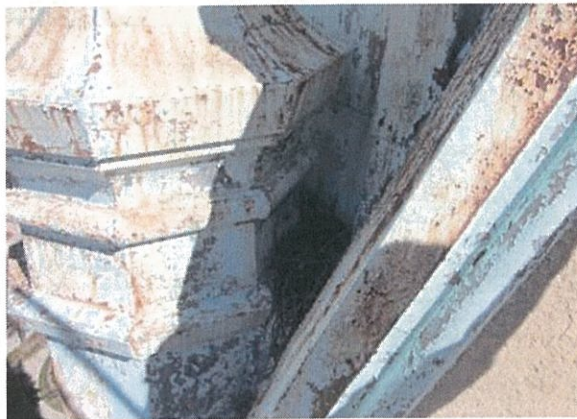
W2

Organic debris in roof valleys

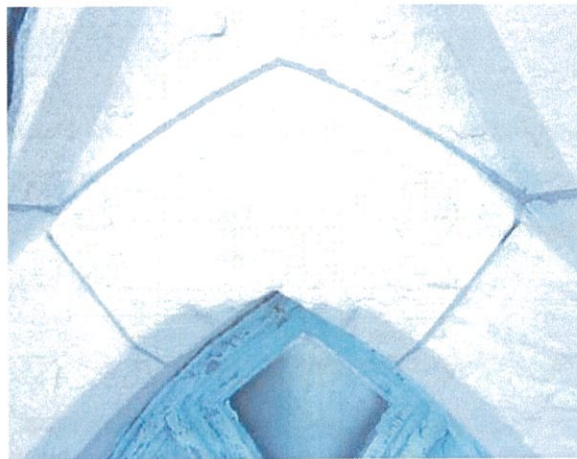
W3

Stone spalling at arch top window head

Remove loose layers and flakes

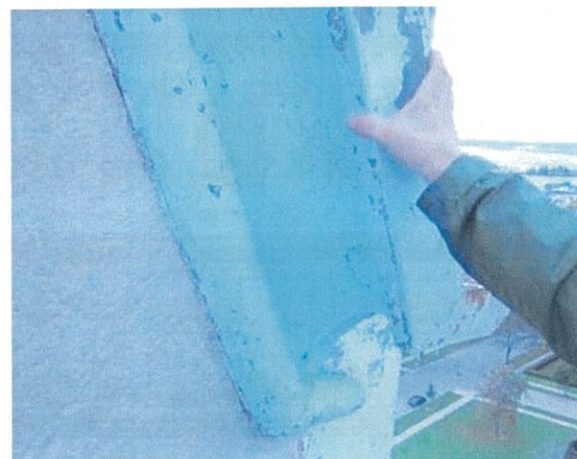
W4

Missing joint sealant and mortar at window casing and roof / stone interface

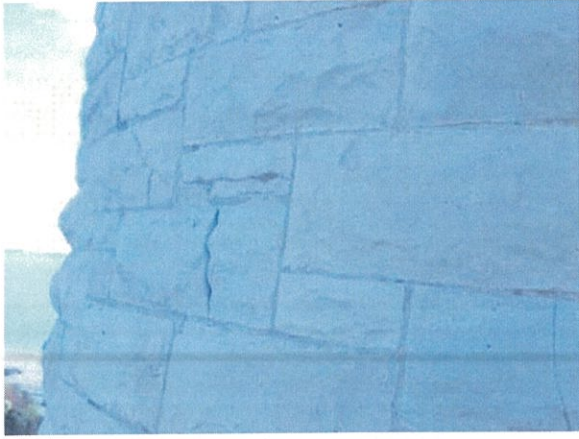
W9

Step cracking at stone and joint adjacent to Window 2. Approx. 3'x3'

Action: Repair stone and repoint mortar joints

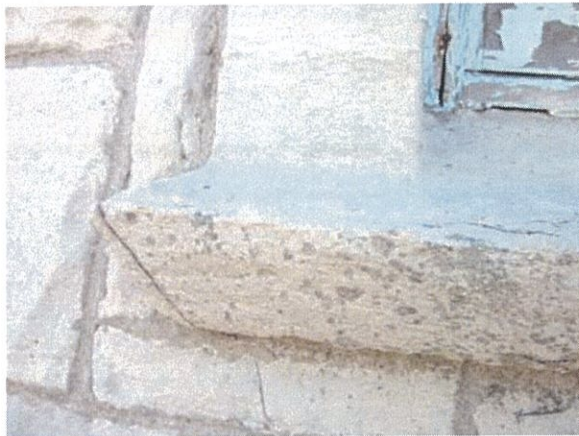
W10

Window 2: Stone sill cracked at north end

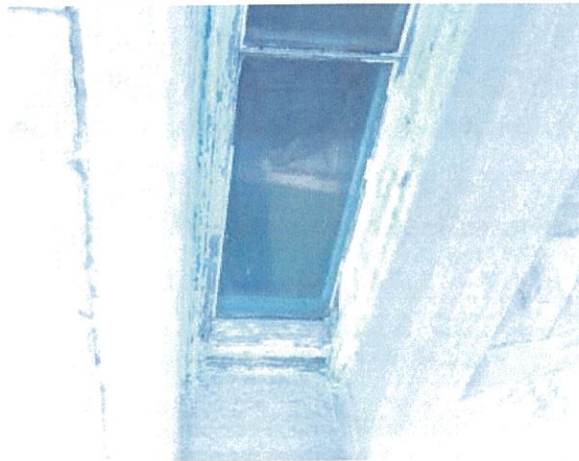
W11

Window 2: Paint peeling across entire surface

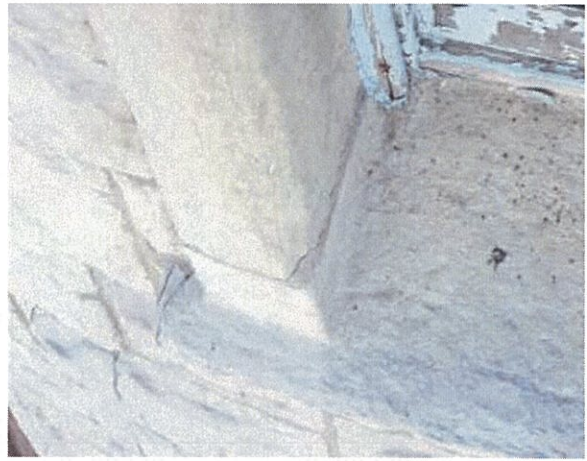
**W14**

Below Window 3: Large cracks at stone and mortar

Repair stone and repoint mortar joints

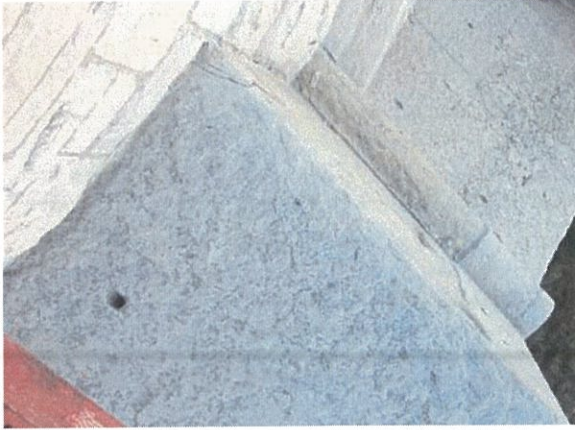
W17

Large horizontal roof: Chipped leading edges and spalling surfaces

Remove loose stone and surfaces

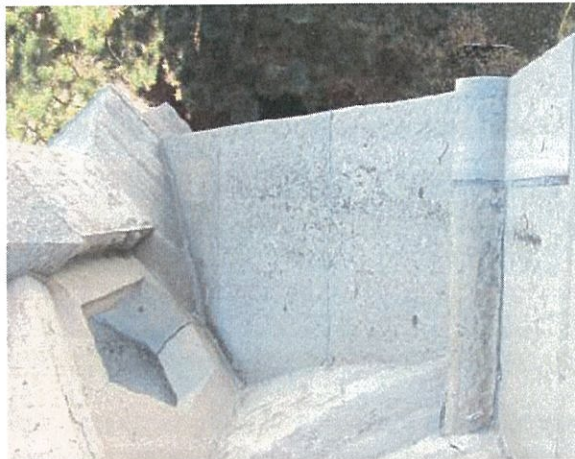
W19

Large Horizontal roof: Spalling surface, missing large mortar joints at SW side

Remove loose layers / flakes and repoint mortar joints

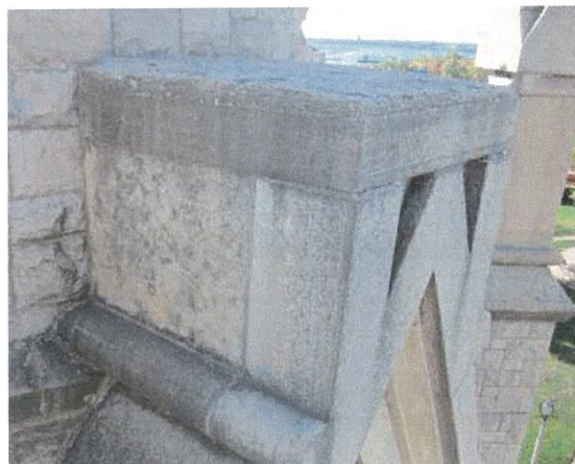
Flying Buttress 4: Missing / deteriorated mortar joints along assembly (5-piece buttress), missing mortar joint at cap stone - tower interface

Repair stone and repoint mortar joints

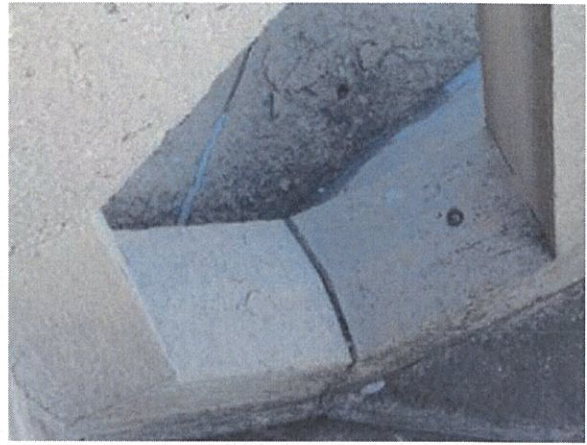
**W20**

Flying Buttress 4: Cracked upper arch piece

Repair stone and repoint mortar joints

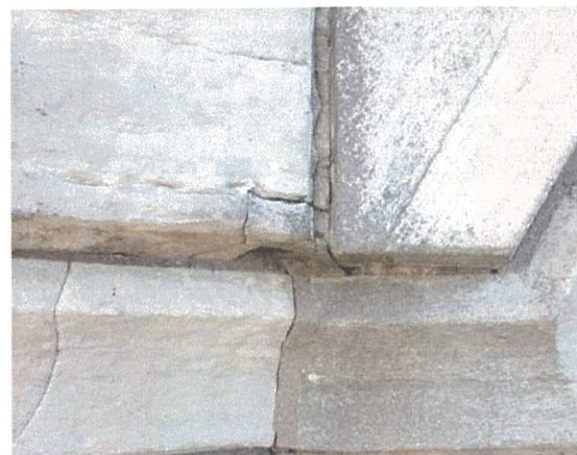
W26

Loose cornice stone and mortar

Repair stone and repoint mortar joints

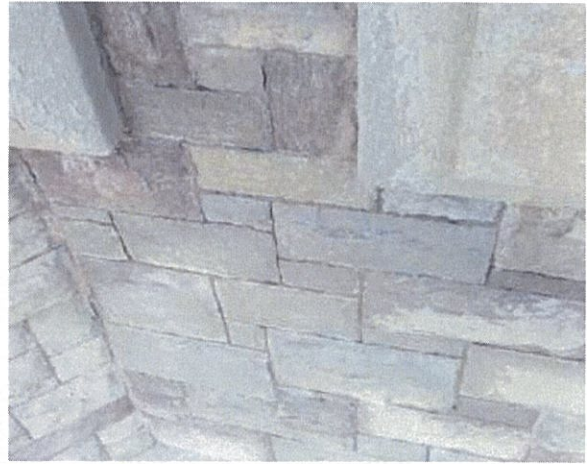
**W27**

Gable roof ridge round profile - spalling along entire ridge

Remove loose layers / flakes

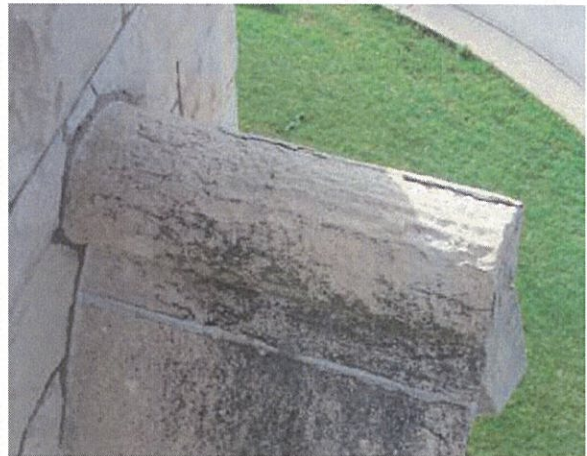
**W28**

Window 4: Stone sill spalling along leading edge

Remove loose layers / flakes

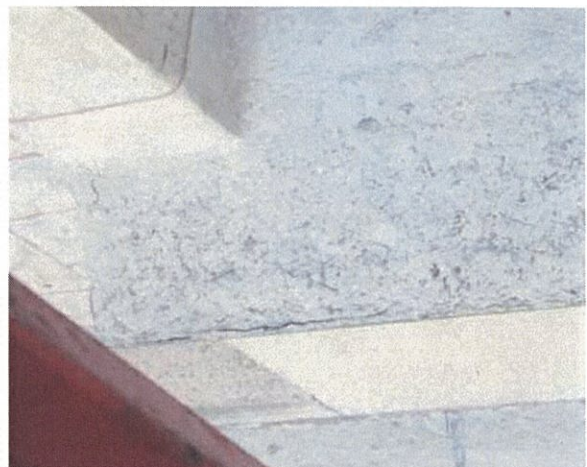
**W29**

Large stone sill spalling along top face and leading edge

Remove loose layers / flakes

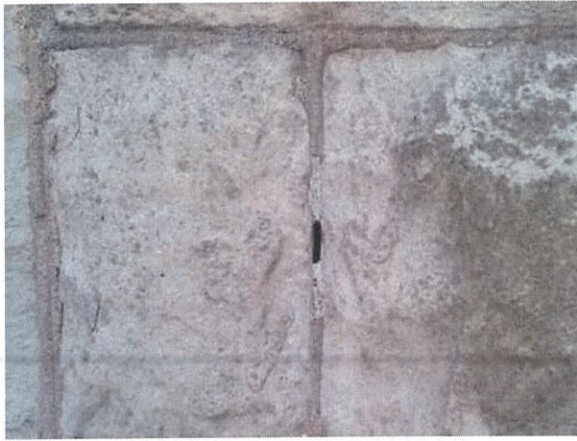
W31

Comment:
Compromised mortar joint

Grade: Minor

Action:
Repoint mortar joints

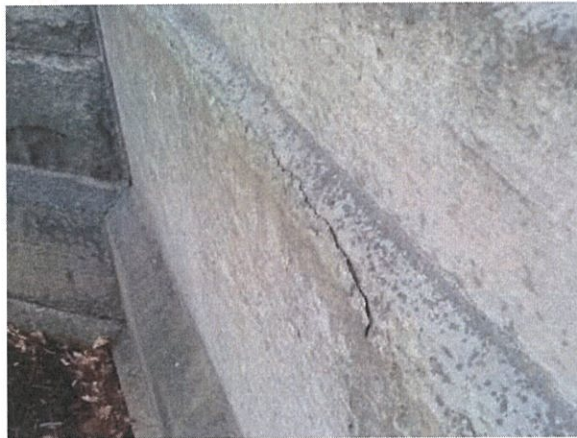
W32

Comment:
Foundation / base stone edge delamination

Grade: Minor

Action:
Repair stone. Remove loose layers / flakes

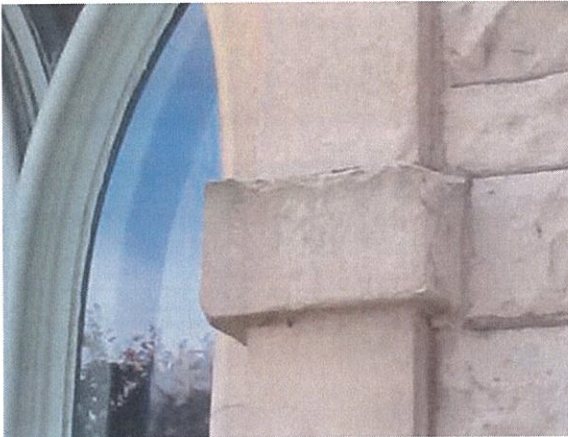
W33

Comment:
Deteriorated corners of stone window detail

Action:
Repair stone

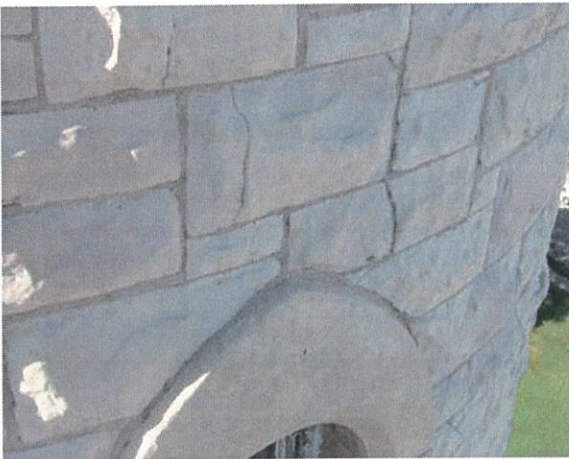
N3

Window 8: Approx. (4) stones split and/or mechanically routed and missing mortar

Grade: Minor

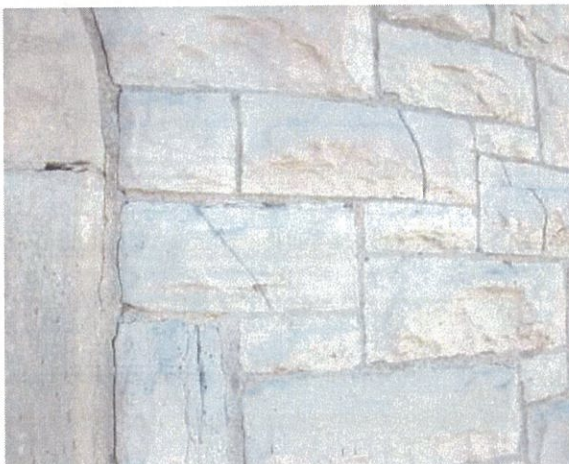
N4

Window 8: Approx. (11) stones split and/or mechanically routed and missing mortar

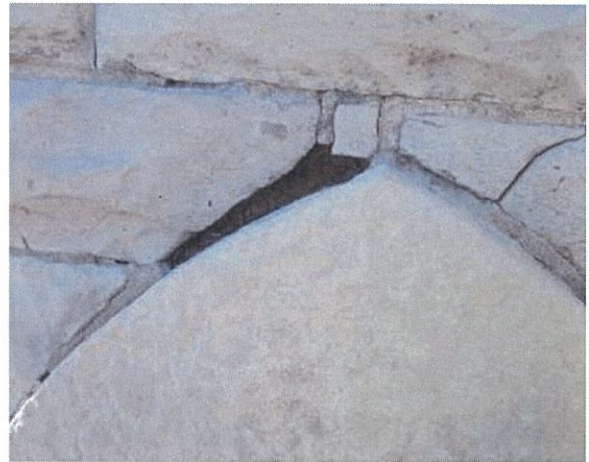
**N5**

Window 9: Missing stone / mortar, split stones at arch top window casing

Grade: Moderate

Replace stone and repoint mortar joints

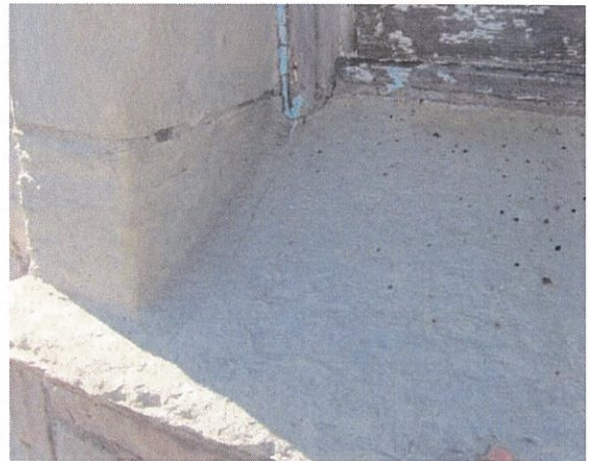
**N6**

Approx. (10) stones split and/or mechanically routed and missing mortar

Grade: Moderate

Route and point with mortar

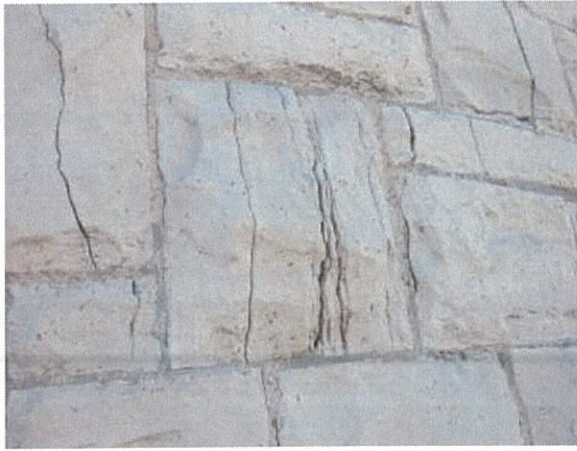
N8

Approx. (10) stones split and/or mechanically routed and missing mortar

Grade: Moderate

Replace stone, route and point w/ mortar

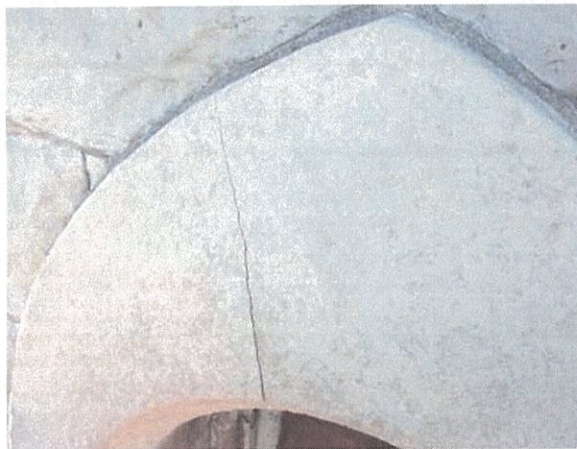
Window 10: Stone arch / window casing: cracked (entire depth)

Grade: Moderate

Repair stone and repoint mortar joints

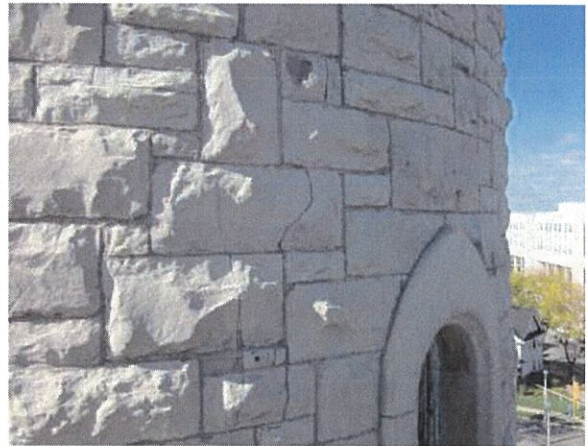
Window 10: Stone sill cracked (leading edge)

Grade: Minor

Repair stone and repoint mortar joints

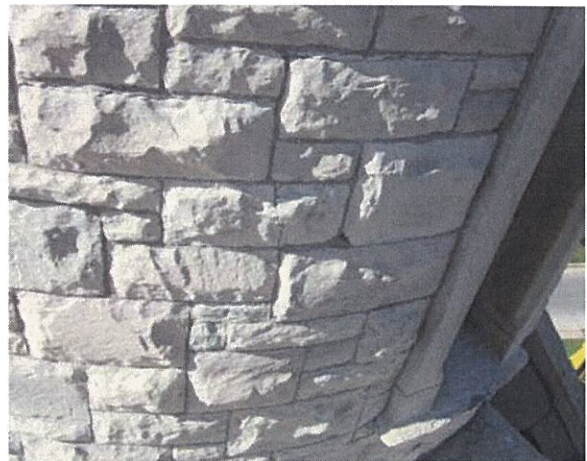
**N10**

Flat Roof: Spalling on top surface, missing mortar at horizontal and vertical joints

Grade: Moderate

Remove loose layers and flakes and repoint mortar joints

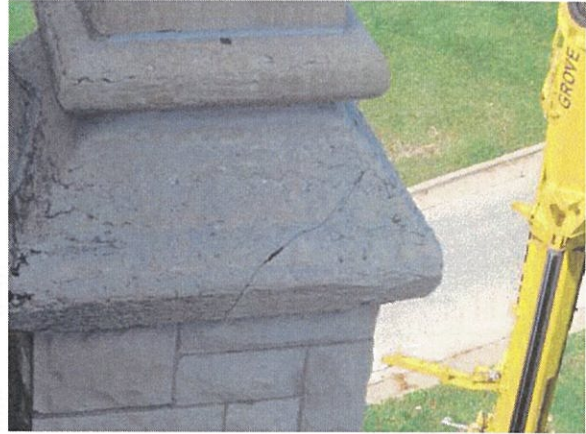
**N14****Comment:**

Stone Finial 2: Mid cap stone is cracked, loose

Grade: Severe (Hazardous)

Hazardous condition abated on 4/11/14. Stone elements have been mechanically restrained by city of Milwaukee on 4/11/14

Replace stone and repoint mortar joints

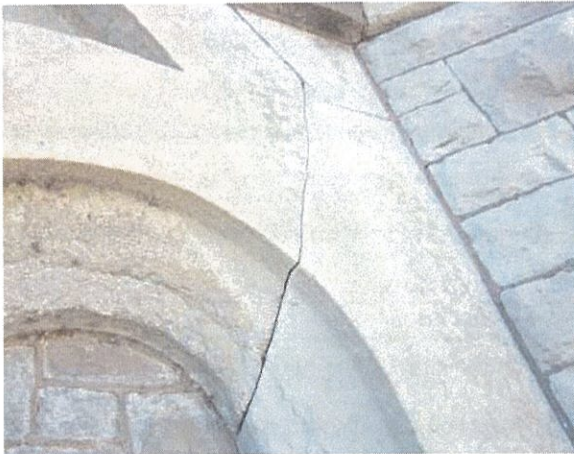
Northwest stone arch pillaster: cracked

Repair stone and repoint mortar joints

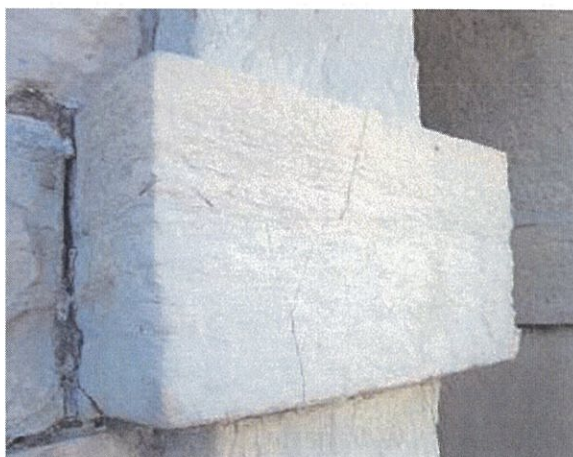
Split stone: 18" x 18"

Grade: Moderate

Repair stone and repoint mortar joints

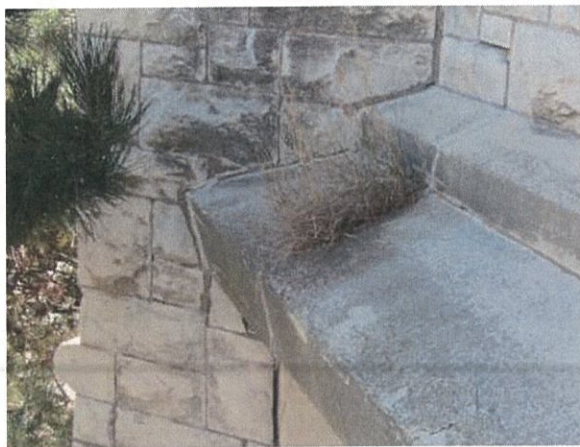
N23

Main horizontal stone sill: Spalling at top and leading edge. Vegetative growth

Grade: Minor

Remove loose stone / surfaces

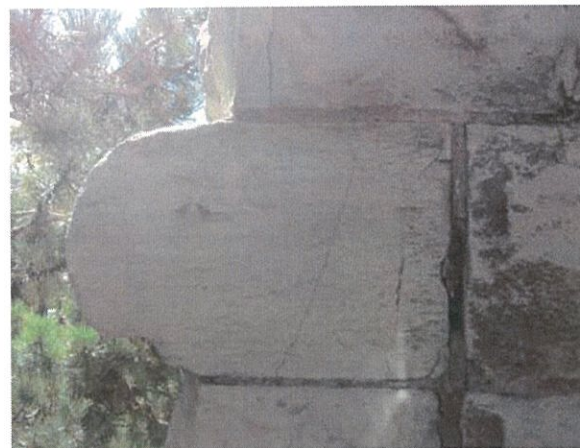
N25

Flying Buttress 2: Bull nose profile: cracked entire vertical thickness

Repair stone and repoint mortar joints

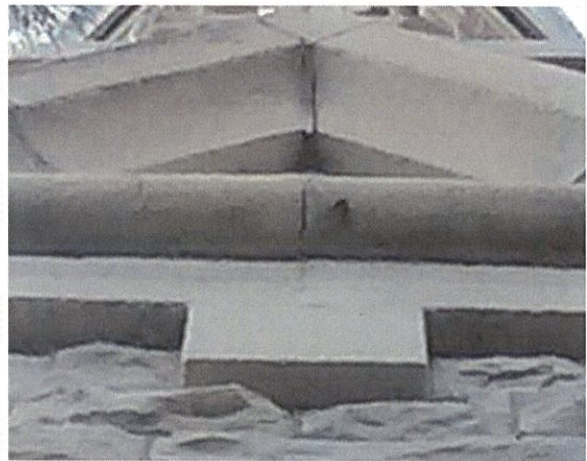
**N29**

Various mortar joints have failed in corner

Grade: Minor

Repoint mortar joints

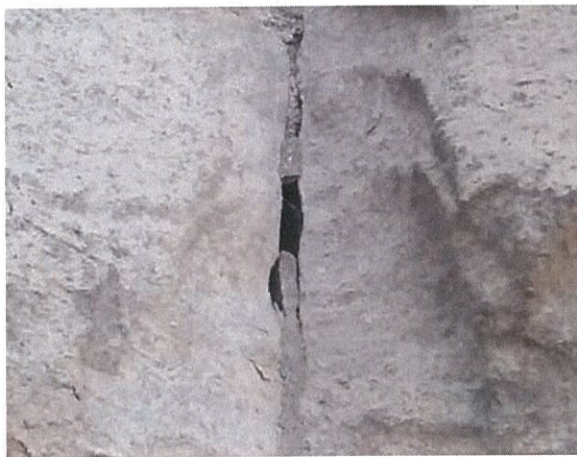
N32

Compromised portion of mortar joint

Grade: Moderate

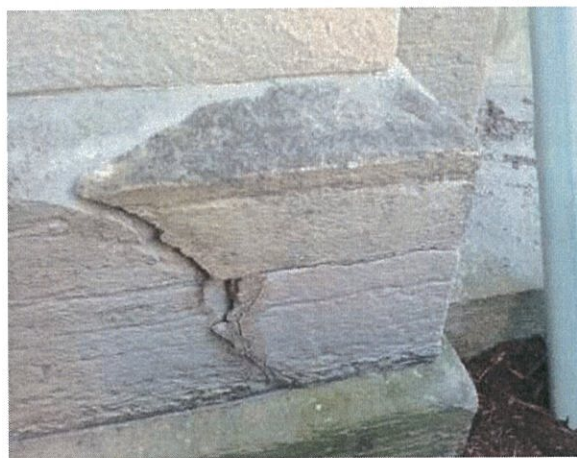
N33

Corner of foundation / base stone has severe crack, may be completely separated. Crack was repaired at one point

Repair stone and repoint mortar joints

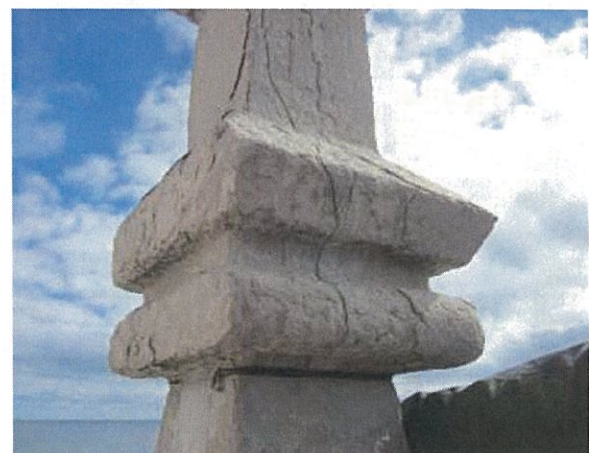
Stone Finial 3: Upper sections / assembly:
vertical and horizontal cracks throughout, large
(10"x10"x6") mortar
patches loose x2, spalling / flaking surface

Upper portion of Finial #3 identified in note S4 was
removed on 10/2013.

Replace stone and repoint mortar joints
Portion of Finial 3 removed from structure on
10/2013

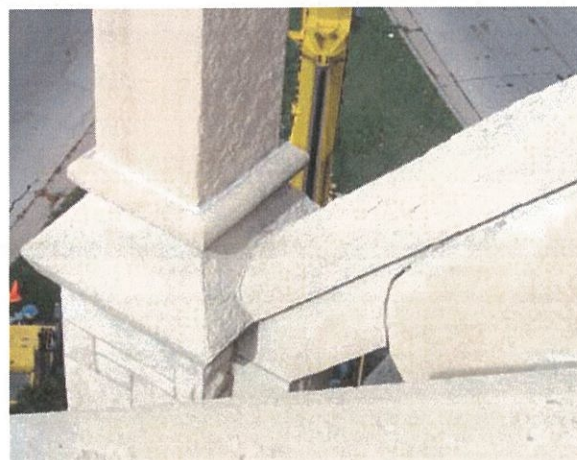
Flying Buttress 4: Cracked upper arch piece, missing mortar

Repair stone and repoint mortar joints

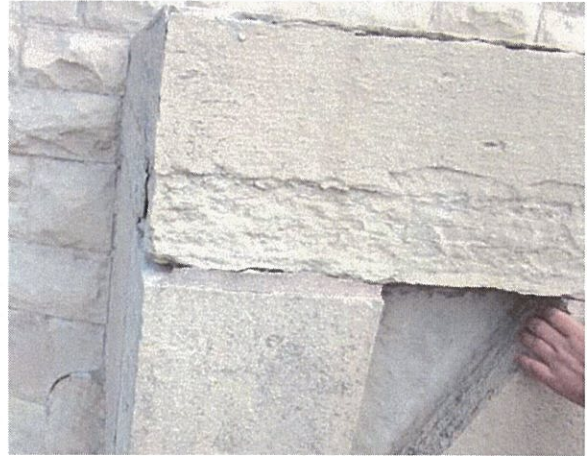
**S7**

Flat Roof: Spalling on top surface, missing mortar at horizontal and vertical joints, loose stones

Grade: Moderate

Remove loose layers / flakes and repoint mortar joints

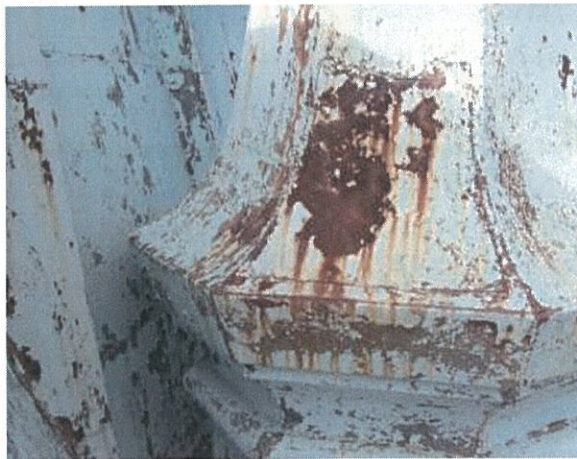
E2

Metal roof / finials: Exterior metal sheeting is intact. Peeling paint and spotting rust across entire surface

Grade: Moderate

Sand, reprime and paint entire surface

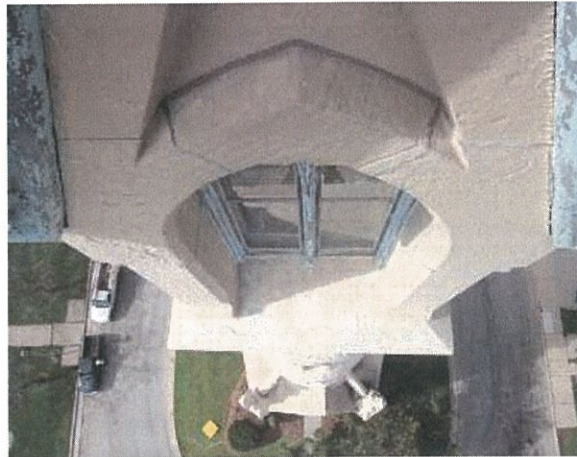
Missing joint sealant and mortar at metal roof / stone interface

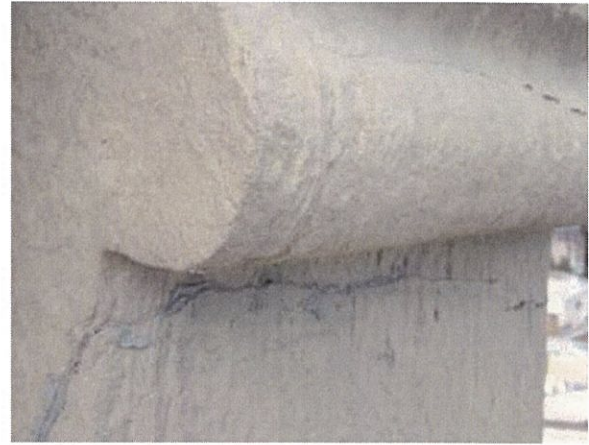
**E3****Action:**

Hairline cracking at corbel

Route and point with mortar

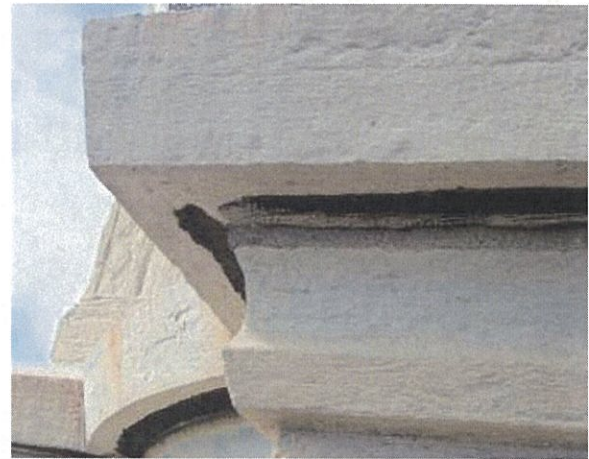
**E4****Action:**

Organic debris / mud dauber nest at underside of horizontal shelf stone

Remove debris and clean

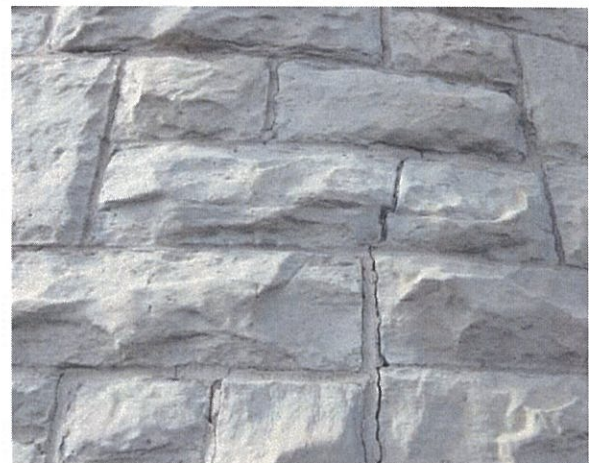
**E5****Action:**

Step cracking at stone and joint at approx. 130' level and extending down to 80' level

Grade: Severe

Repair stone and repoint mortar joints

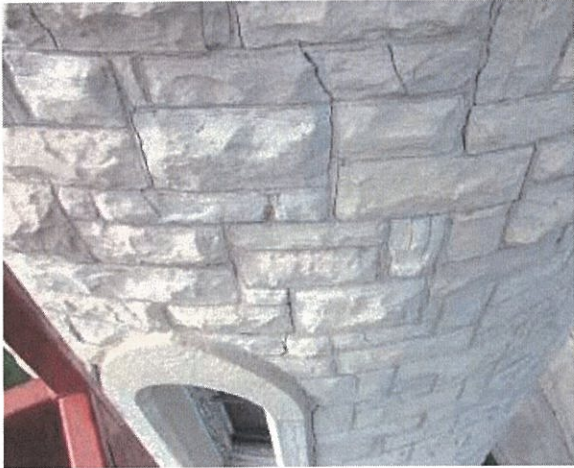
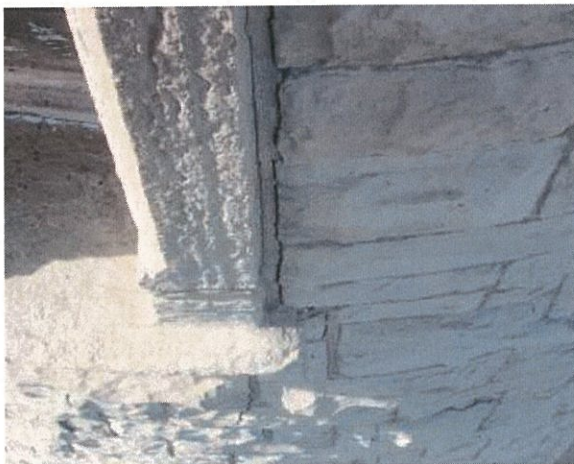
Step cracking at stone and joint at approx 130' level and extending down to 80' level

Grade: Severe

Repair stone and repoint mortar joints

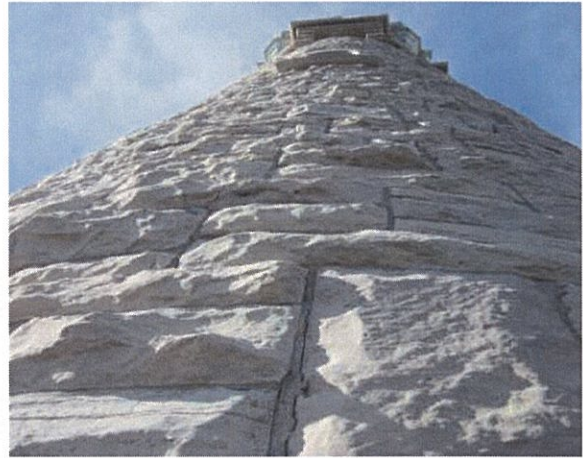
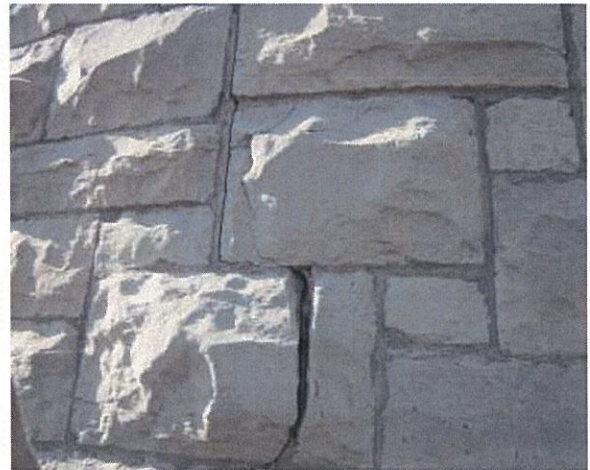
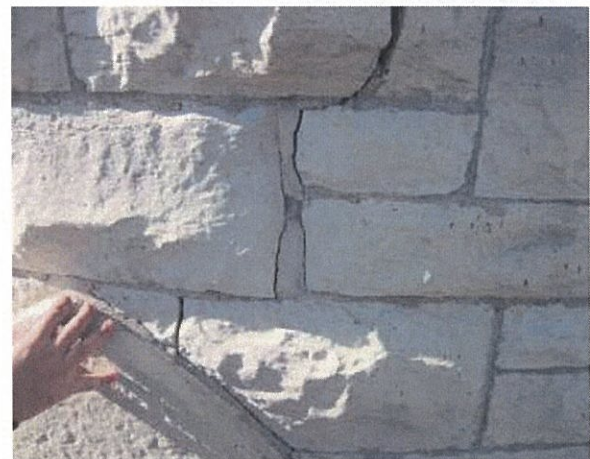
E5

Step cracking at stone and joint at approx. 130' level and extending down to 80' level

Grade: **Severe**

Repair stone and repoint mortar joints

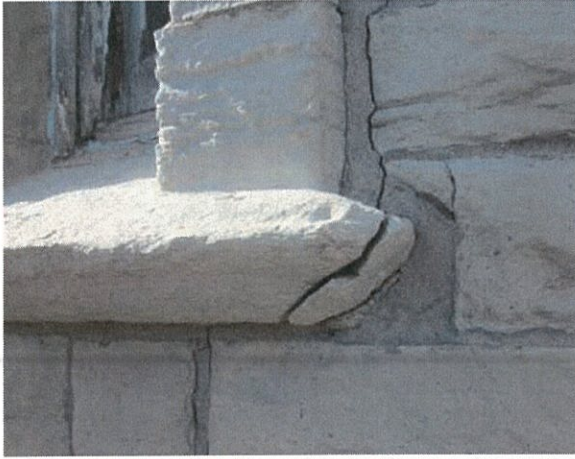
Step cracking at stone and joint at approx 130' level and extending down to 80' level

Grade: Severe

Repair stone and repoint mortar joints

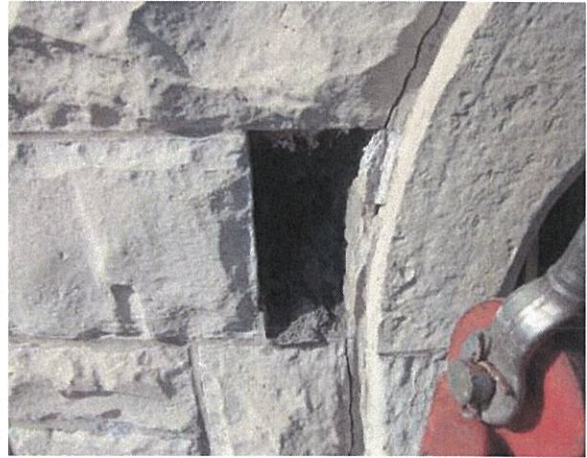
**E6**

Window 22: Loose stone (10x6x4) removed and in hand (stone given to client)

Grade: Minor

Update Comment: Exterior glass lite missing (6/24/14).

Replace stone

Action: Replace glazing and patch window frame.

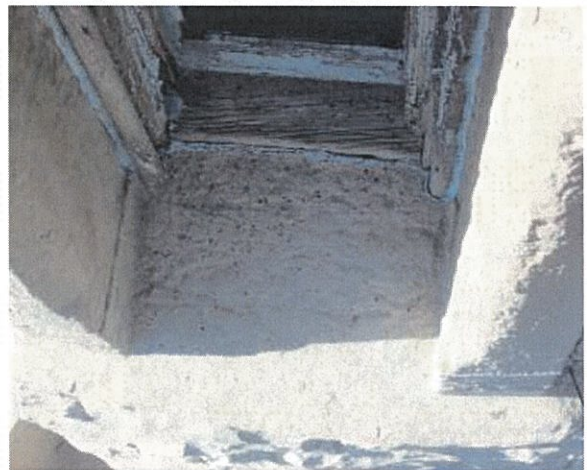
**E7**

Window 23: Stone sill cracked in multiple places

Grade: Minor

Repair stone and repoint mortar joints

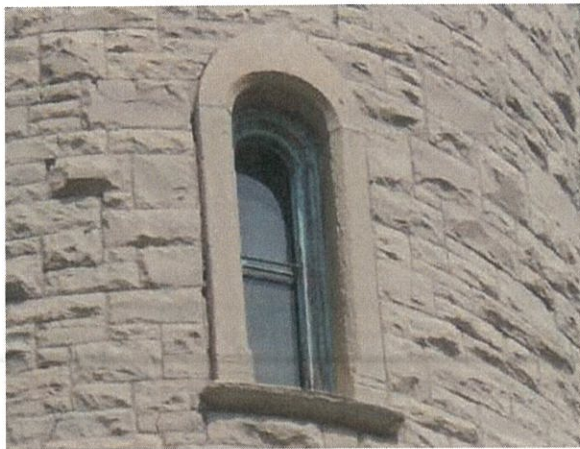
E7

Update Comment: Exterior glass lites missing (6/24/14).

Action: Replace glazing and patch window frame.

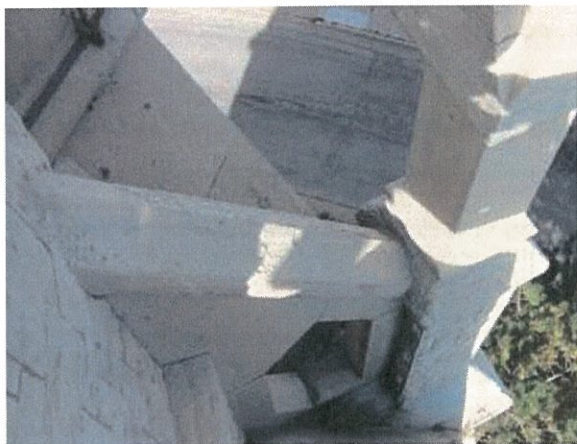
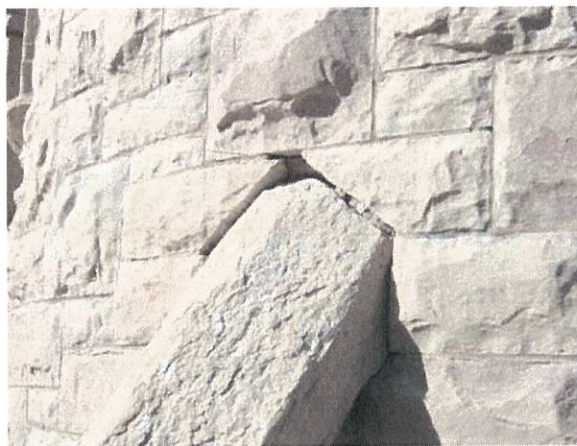
E9

Flying Buttress 2 & 3: Missing / deteriorated mortar joints along assembly (5-piece buttress), missing mortar joint at cap stone - tower interface

Grade: Moderate

Repair stone and repoint mortar joints

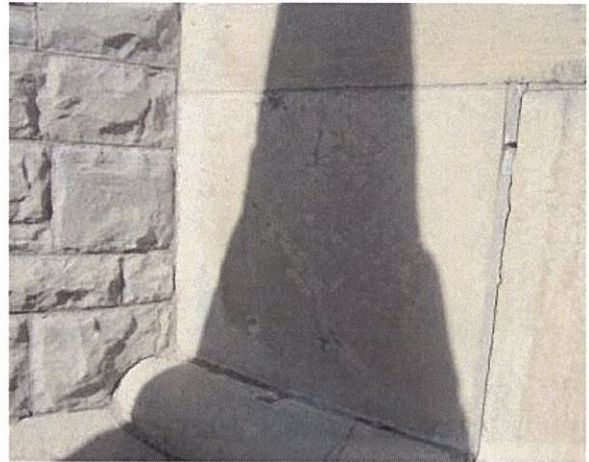
**E10**

Flat Roof: Spalling on top surface, missing mortar at horizontal and vertical joints

Grade: Moderate

Remove loose layers / flakes and repoint mortar joints

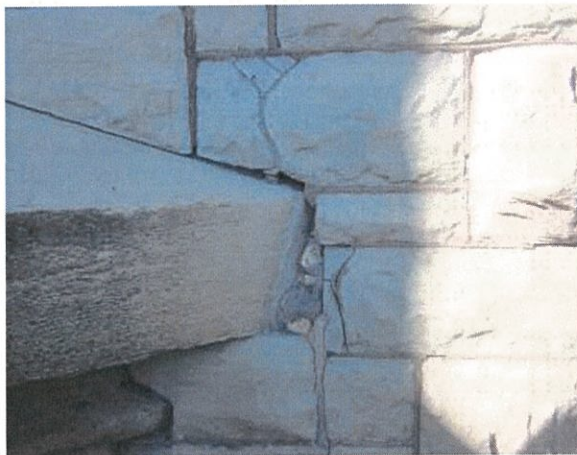
E13

Main horizontal stone sill: Spalling at top and leading edge. Vegetative growth, loose stones and missing mortar at edges

Grade: Moderate

Remove loose stone / surface, repair stone and repoint with mortar

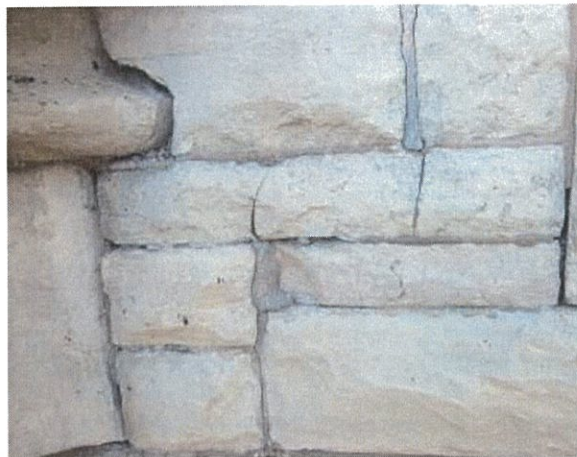
E14

Upper portion of arch is deteriorated. Face of stone is delaminated 3/4" - 1" less than adjacent stones

Remove loose layers / flakes

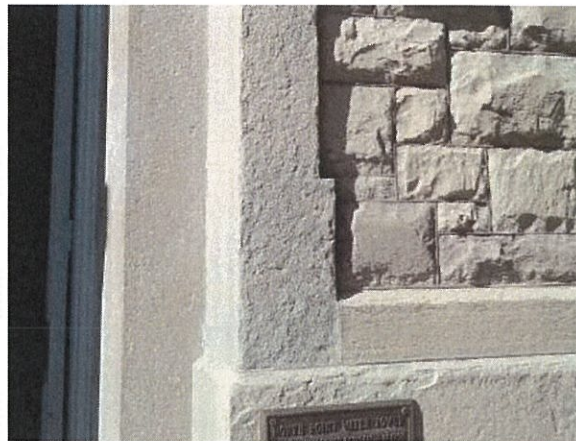
**E15**

Upper portion of arch is deteriorated. Face of stone is delaminated 1/4"-3/8" less than adjacent stones

Grade: Minor

Remove loose layers / flakes

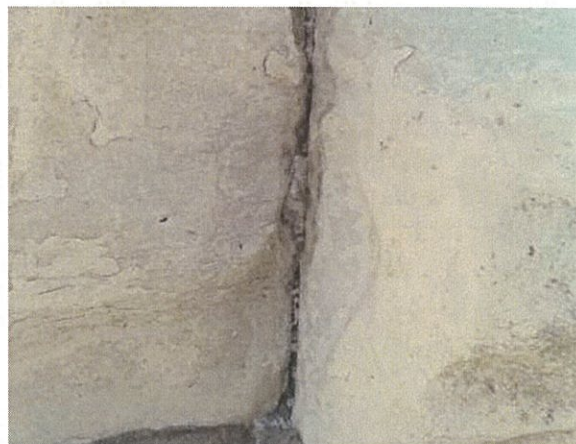
**E16**

Various locations of corner the tuckpointing is failing

Grade: Minor

Repoint mortar joints

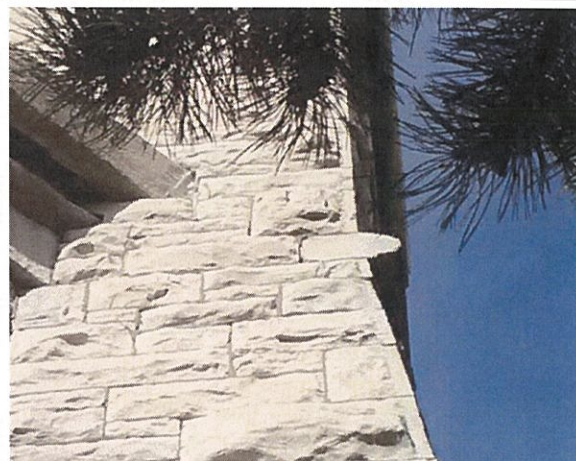
**E17**

Enlarged vertical mortar crack between buttress and rounded stone profile

Grade: Minor

Repoint mortar joints
