Façade Critical Examination Ordinance Report

2015 Follow-up

City of Milwaukee
North Point Water Tower

August 5, 2015

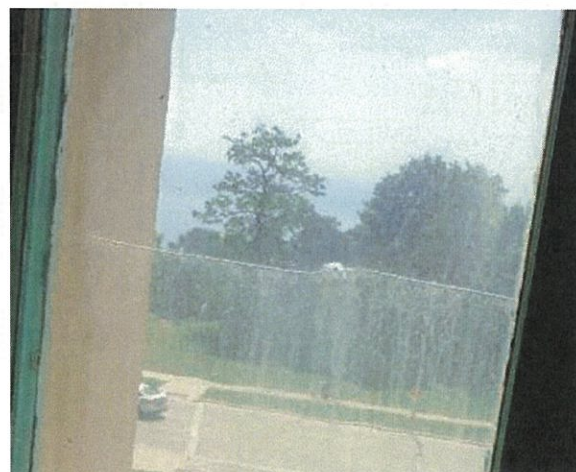
**E18**

Projectile damage to outer lite of glass.

Grade: Minor

Replace existing lite with new.
